# Manhole Inspection Summary

Manhole # S27C\_\_034MH

Insp Date: **12/7/07 2:19 PM**

**Location** Address: **814 FRANKLIN ST**

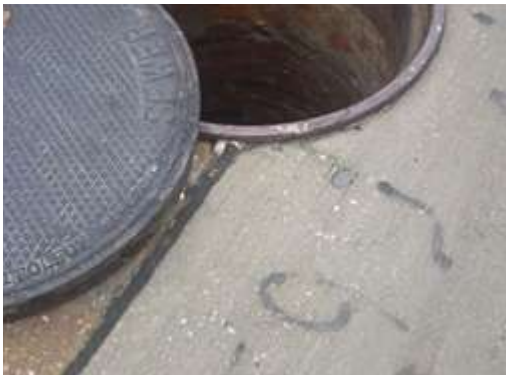
Defect 1

**Cover** Shape: **Circular** Diameter: **24** (in.) Length: (in.) Dist A/B Grade: **1** (in.)

GRADE ADJ

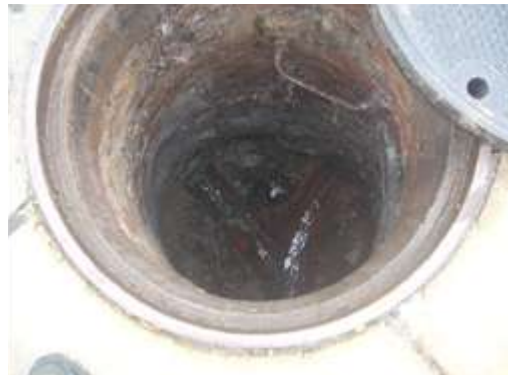
Defect 2

**Steps** Count: **5** Missing: **0** ☒ **Corroded**

CORRODED STEPS

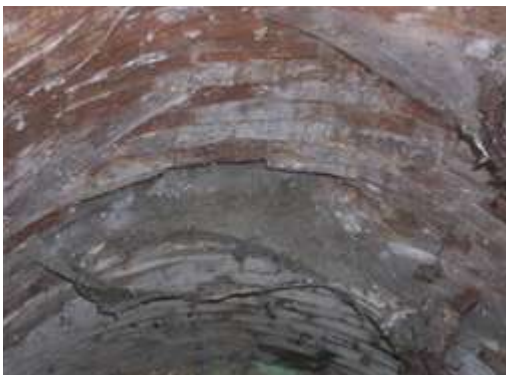
Defect 3

Comments **CORBEL IS VERY DETERIORATED**

Condition: ☐ Sound ☐ Cracked ☐ Root Intrusion ☐ Loose Brick ☒ **Deteriorated**

CORBEL DETERIOATION

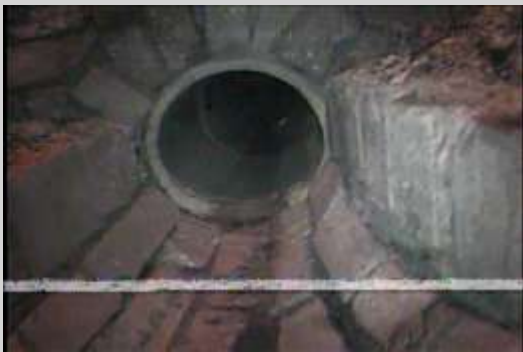
12 O'Clock Outflow

Pipe Height: **8.4** (in.) Rod and Bar (Angled)  
Pipe Material: **Clay** ☐ Pipe Lined  
Invert Depth: **9.49** (ft.) Flow Characteristics: **Slow**  
Deposits: ☒ None ☐ Mud ☐ Sludge ☐ Debris ☐ Grease  
Silt Depth: (in.) Deposits Extent:  
Infiltration: **None** Pipe Seal Cond: **Sound**

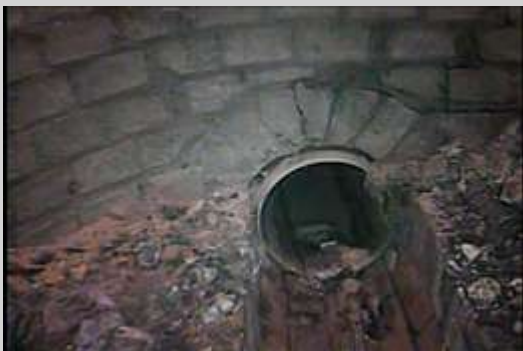
5 O'Clock Inflow

Pipe Height: **8.4** (in.) Rod and Bar (Angled)  
Pipe Material: **PVC** ☐ Pipe Lined  
Invert Depth: **8.93** (ft.) Flow Characteristics: **Slow**  
Deposits: ☒ None ☐ Mud ☐ Sludge ☐ Debris ☐ Grease  
Silt Depth: (in.) Deposits Extent:  
Infiltration: **None** Pipe Seal Cond: **Sound**

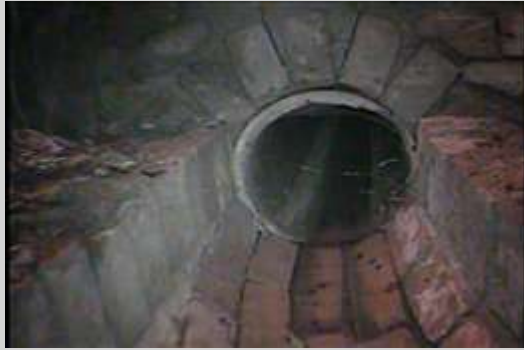
8 O'Clock Inflow

Pipe Height: **7.2** (in.) Rod and Bar (Angled)

Pipe Material: **Clay** ☐ Pipe Lined

Infiltration: **None** Pipe Seal Cond: **Sound**
